Phase 1 Inspection Report Kalihiwai Reservoir (KA- 0024)

State of Hawaii Department of Land and Natural Resources

Project number: 60662036

September 20, 2022

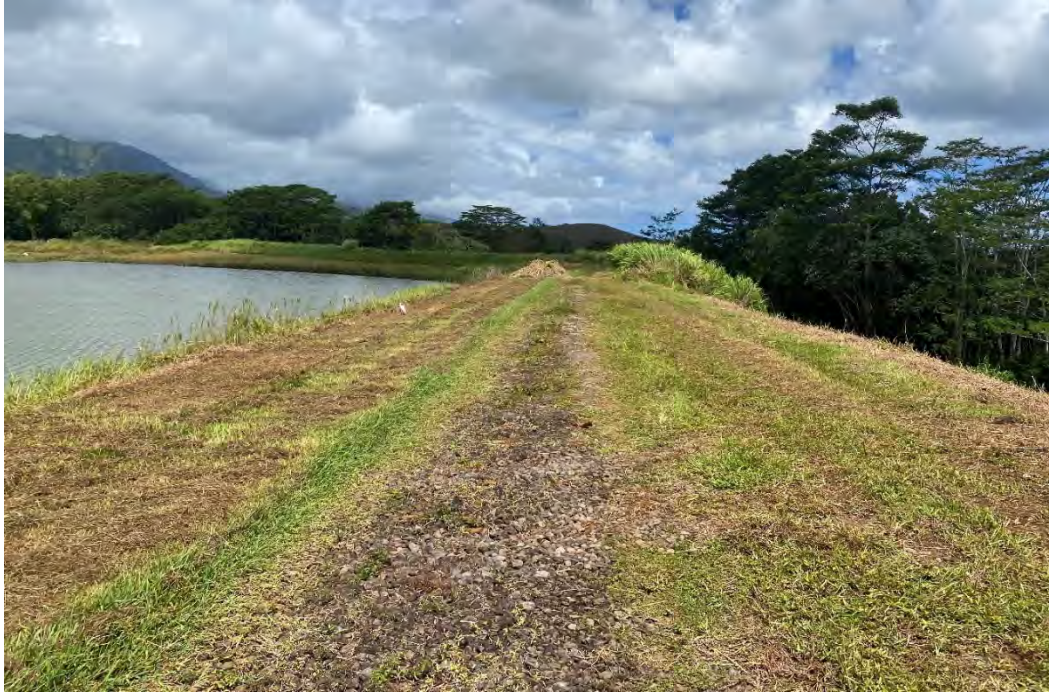
The embankment crest consists of a single lane, graveled access road, as shown in Photo 2-2 below. There is some uncertainty in the embankment crest elevation. The 2022 EAP and 2018 O&M Manual list the embankment crest elevation as 396 feet while the 2021 Gannett Fleming Draft Final Design Report lists the embankment crest elevation as 394.8 feet to 397.2 feet. The upstream embankment slope is approximately 2 horizontal to 1 vertical (2H:1V) and is grass covered, as shown in Photo 2-3 and Photo 2-4. The downstream embankment slope varies from approximately 0.6H:1V to 2H:1V. There were portions of the downstream slope with were near vertical, most prominently along the upper portion of the left embankment downstream slope. The downstream slope is grass covered as shown in Photo 2-5. However, a few portions of the downstream slope and toe were densely vegetated with taller grass and the toe portion of the right downstream embankment segment was exposed and includes a seepage collection ditch. Debris from previous vegetation removal was also present on the downstream slope. Erosion control matting was observed on the downstream embankment slope near the right abutment as shown in Photo 2-6.

Photo 2-2: Embankment Crest looking Right

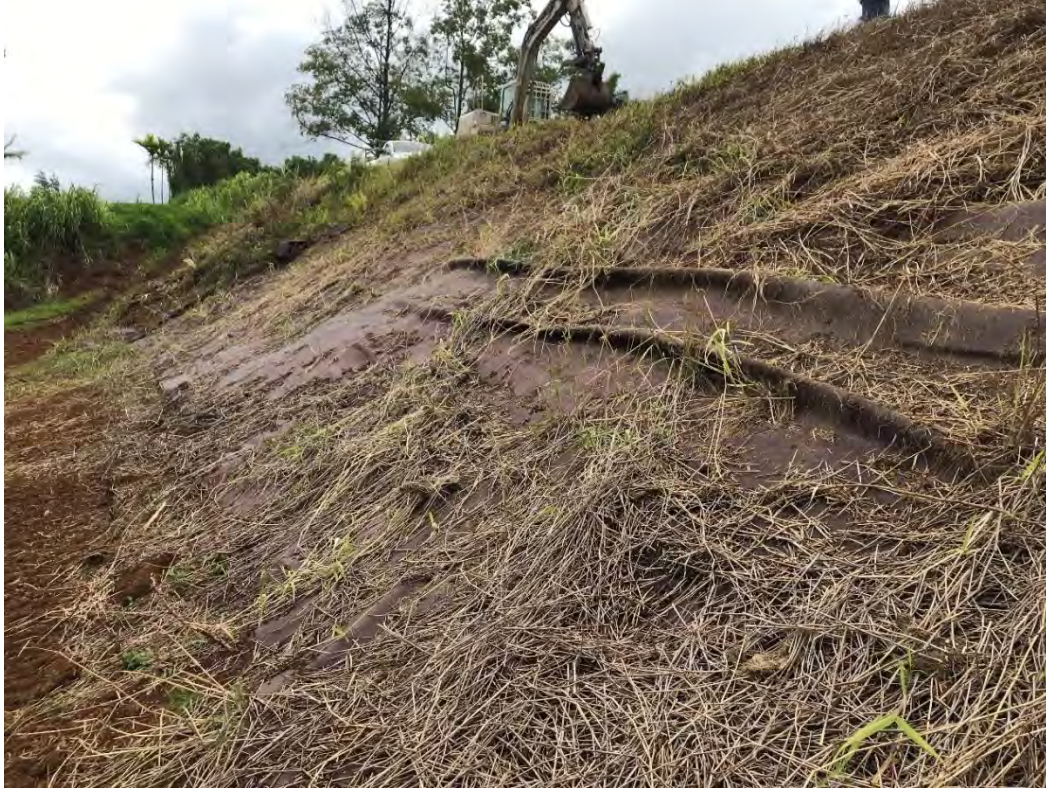
Photo 2-6: Erosion Mat along Downstream Embankment Slope. Looking towards Right Abutment

The slopes are relatively steep and appear to have experienced erosion in the past. The embankment overtopped in 2018 and slope repairs were reportedly completed including placing localized backfill in the area of a slump that occurred in the downstream slope and placing a turf reinforcement mat.

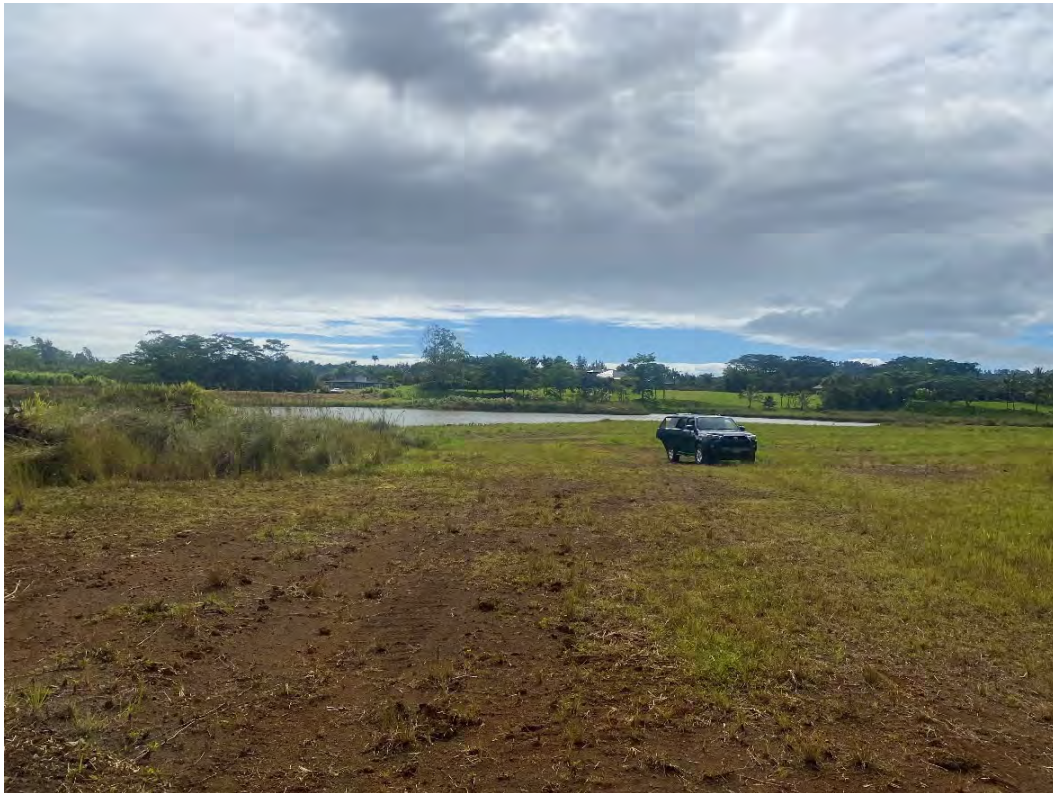
Photo 2-7: Spillway Approach (looking upstream towards reservoir)

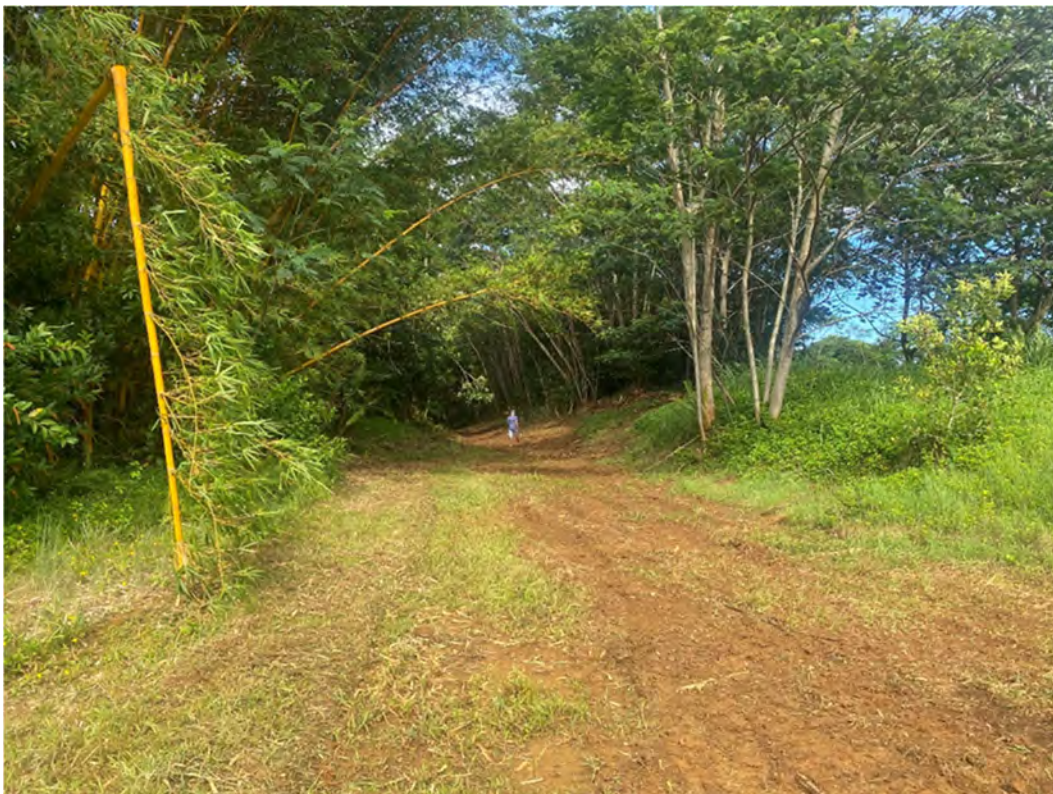
Photo 2-8: Spillway Discharge Channel (looking downstream)

- c. Backfill and monitor existing depressions due to tree removal along the embankment crest and slope for changing conditions.
 - d. Continue to remove excessive vegetation and debris from the spillway crest section and discharge channel to allow free flow through the channel.

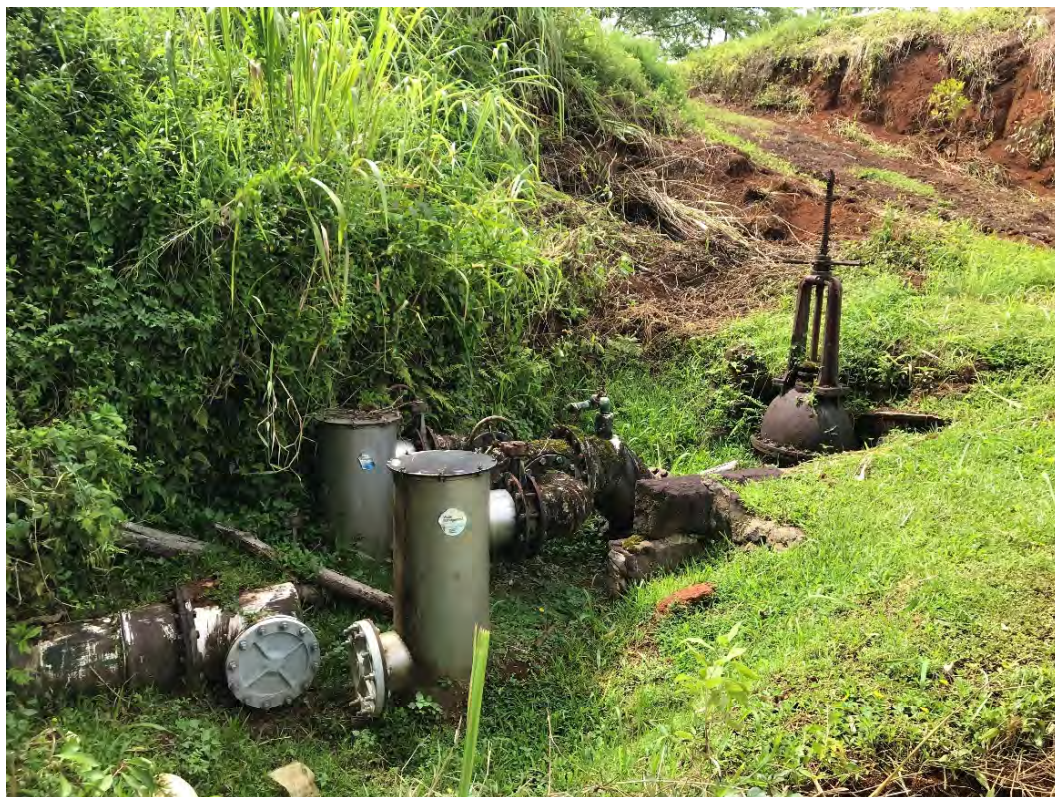
Photo 2-10: Low Level Outlet Works Valve at Downstream Embankment Toe (Outlet #1)

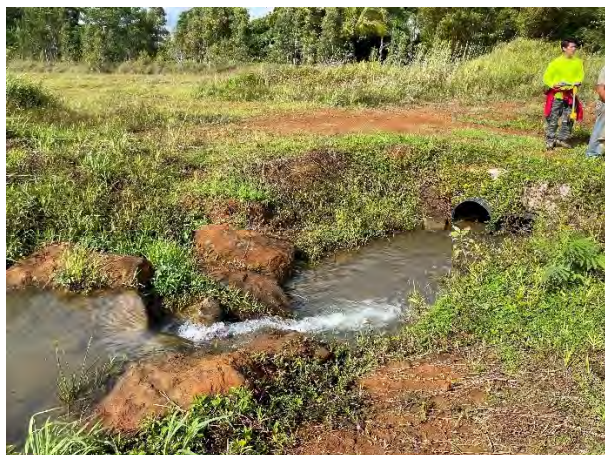
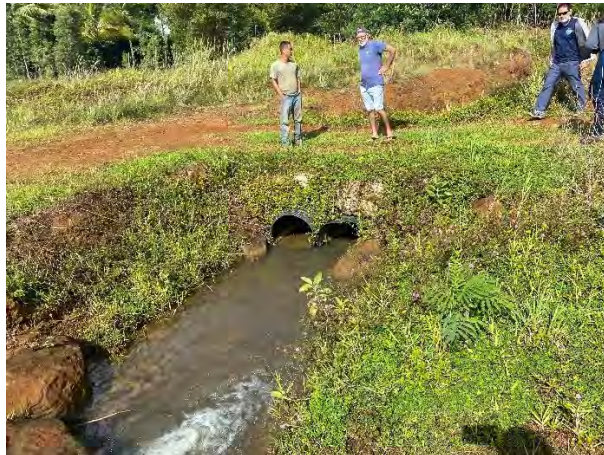
The mid-level outlet works (Outlet #2) historically consisted of an approximately 30-inch diameter corrugated metal pipe (CMP) with an upstream slide gate located near the left abutment. The mid-level outlet gate structure was removed during the flood of 2018 to increase discharge capacity and replaced in 2020 with two ungated 24-inch diameter HDPE pipes which discharge to an unlined channel.

Photo 2-11: Mid-level Outlet (Outlet #2)

3. **Mid-Level Outlet (Outlet #2) Modifications.** The HDPE conduits currently installed at the mid-level outlet (also referred to as Outlet #2) should be modified to a more permanent and robust structure with known invert elevation and discharge capacity either as a separate outlet with upstream control or incorporated as part of a spillway modification. In the interim, the elevation and correlated staff gage height of this outlet and the restricted pool level should be confirmed by survey. See also Priority 2 Recommendation 4.

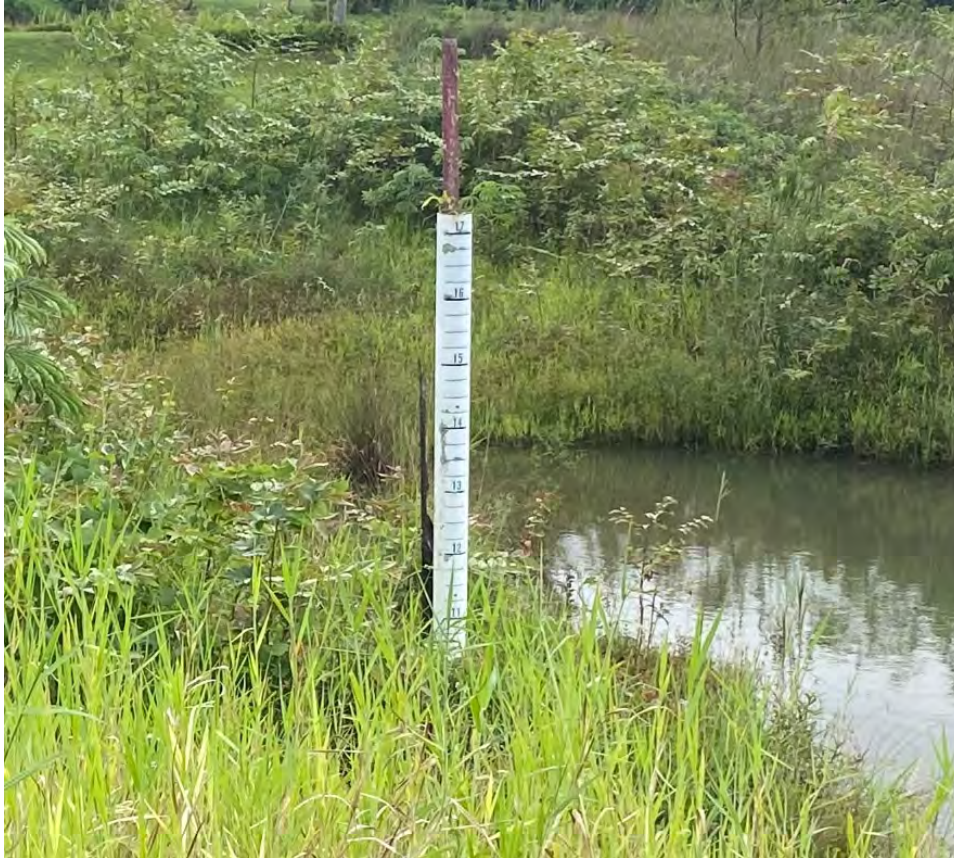
The reservoir staff gage and automated staff gage are used to measure the pool elevation. The staff gage consists of water level markings spaced at quarter-foot increments painted on the downstream side of white boards installed within the reservoir, as shown in Photo 2-13. The automated staff gage consists of an automated data acquisition system that provides real-time reservoir monitoring and is shown in Photo 2-14.

Photo 2-13: Close-up of Manual Reservoir Staff Gage Near Right Abutment

- e. Maintain short vegetation at the location of the staff gage (or move staff gage to an alternate location not prone to vegetation cover – see also Priority 2 Recommendation 3)

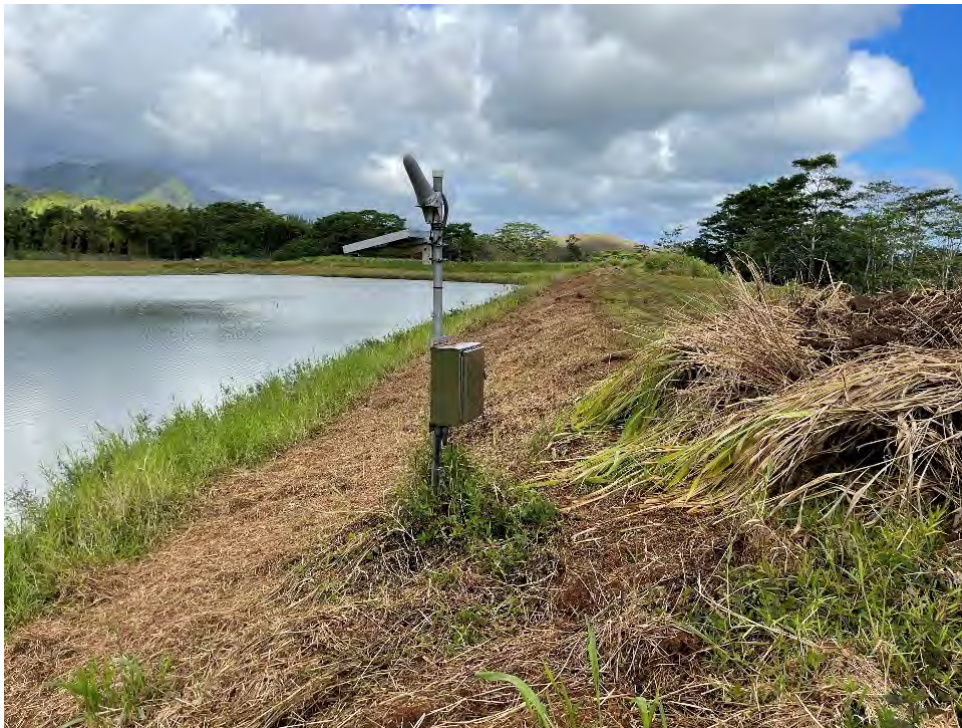
Photo 2-14: Close-up of Automated Staff Gage Near Right Abutment

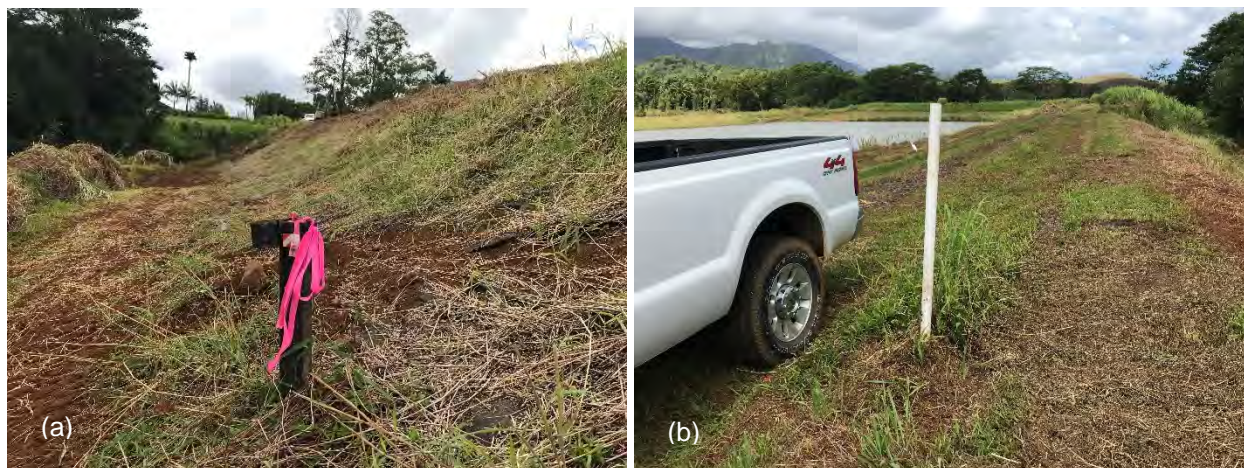
At the time of the 2021 Phase 1 inspection, the piezometers were not being regularly recorded and data was not available for review. However, some historical monitoring data is available in the 2021 Gannett Fleming report. Based on historic data from two of the piezometers, piezometer levels show correlation with water levels in the reservoir. Piezometers PZ-1 and PZ-2 are shown in Photo 2-15.

Photo 2-15: Piezometers: (a) PZ-1 Located near Middle of Right Embankment Toe and (b) PZ-2 Located near Middle of Right Embankment Crest

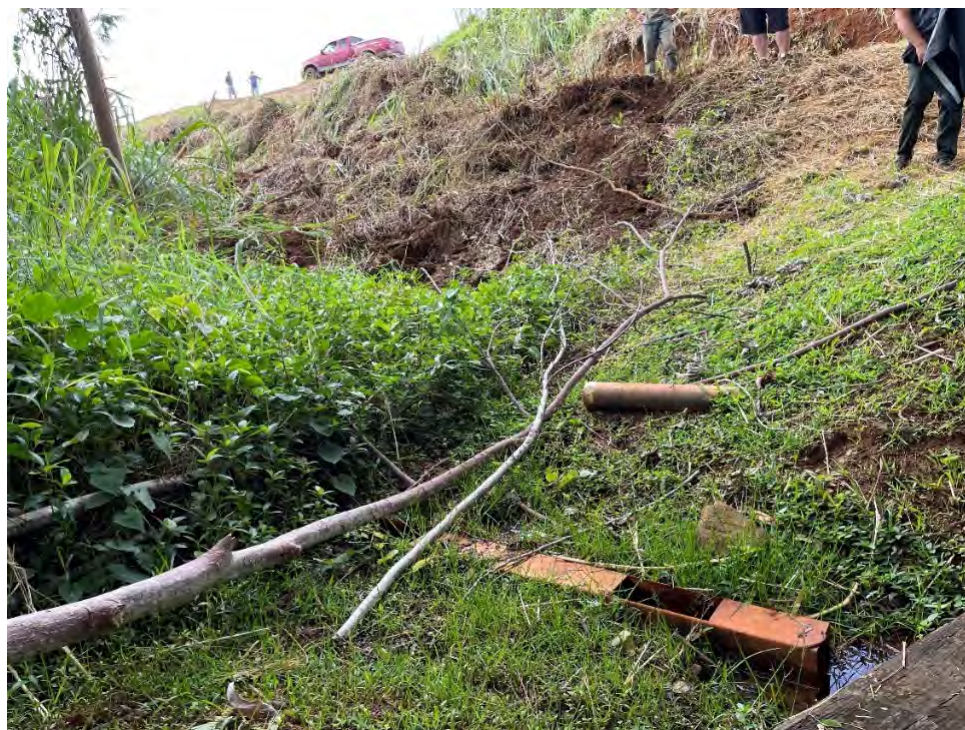
The inlet was closed as part of the normal operations under the restricted reservoir level and therefore the inlet flume was not being actively monitored. The flume located at the downstream toe of the right embankment segment is measured as part of the routine/daily inspections and recorded on the daily log. The flume reportedly flows in the range of 5 to 10 gallons per minute (gpm) under the restricted pool level and up to about 20 gpm under previously normal operating conditions. It was noted that the logbook for the month of July 2021 references a seepage volume of 10,000 gallons per minute (labeled as the S-1 location in the daily log), which was stated to be a data entry error. It was recorded to be about 10 gpm for the month of June 2021 and was estimated to be approximately 2 gpm at the time of the 2021 Phase 1 inspection.

Photo 2-16: Flume to Monitor Seepage at Downstream Toe of Right Embankment Segment

5. **Develop a Plan for Collecting, Measuring and Monitoring Seepage.** Based on past performance, seepage is judged to be a concern when the reservoir is operating with a full normal storage. Existing seepage areas at the toe of the embankment should be monitored regularly for changing conditions such as increase in flows, muddy flows, and turbidity or sediment in the discharge. Seepage should be kept clear of vegetation and regularly monitored as part of the routine inspections for developing changes such as increase in seepage flow, cloudy or muddy seepage flow, or discharge of soil particles. Observations made during inspections should be noted on the daily and monthly activity logs, as appropriate. Reservoir level should always be noted at the time of

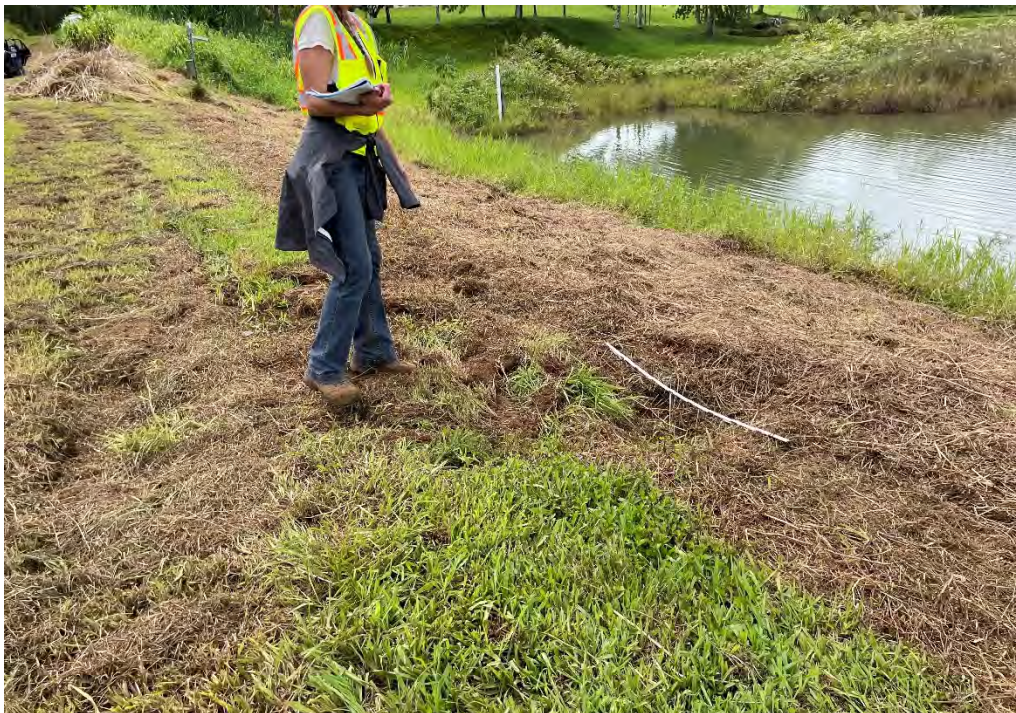
Photo B-12: Depression in Dam Crest on Right Embankment Segment (reportedly from brush removal)

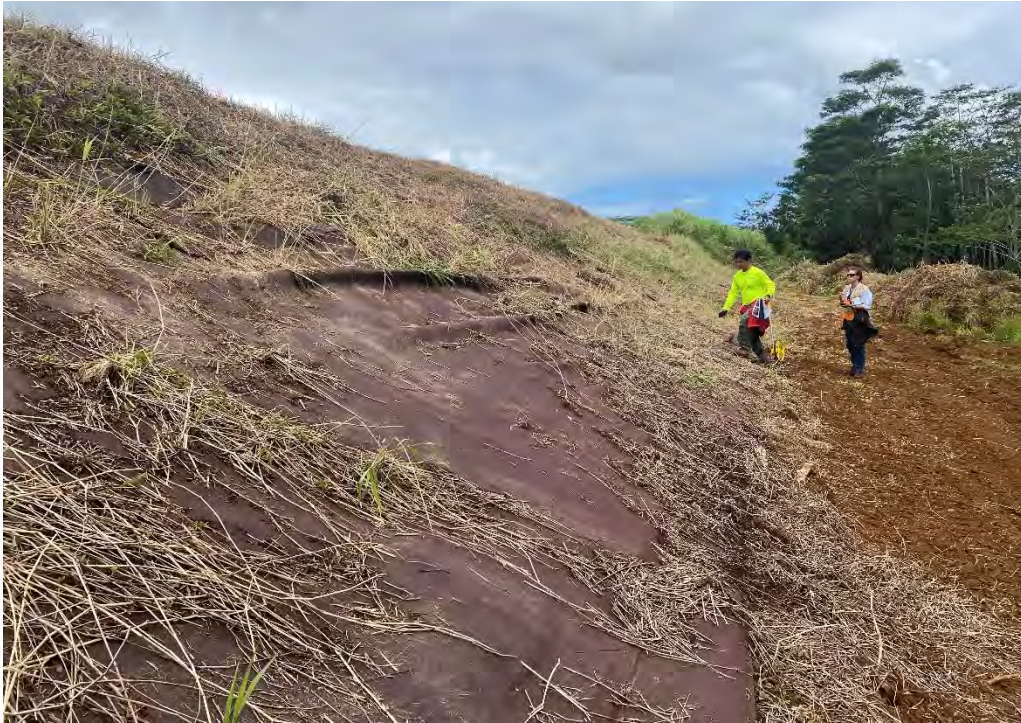
Photo B-21: Downstream Embankment Slope and Slope Erosion Protection, Right Embankment Segment (looking left from near right abutment).

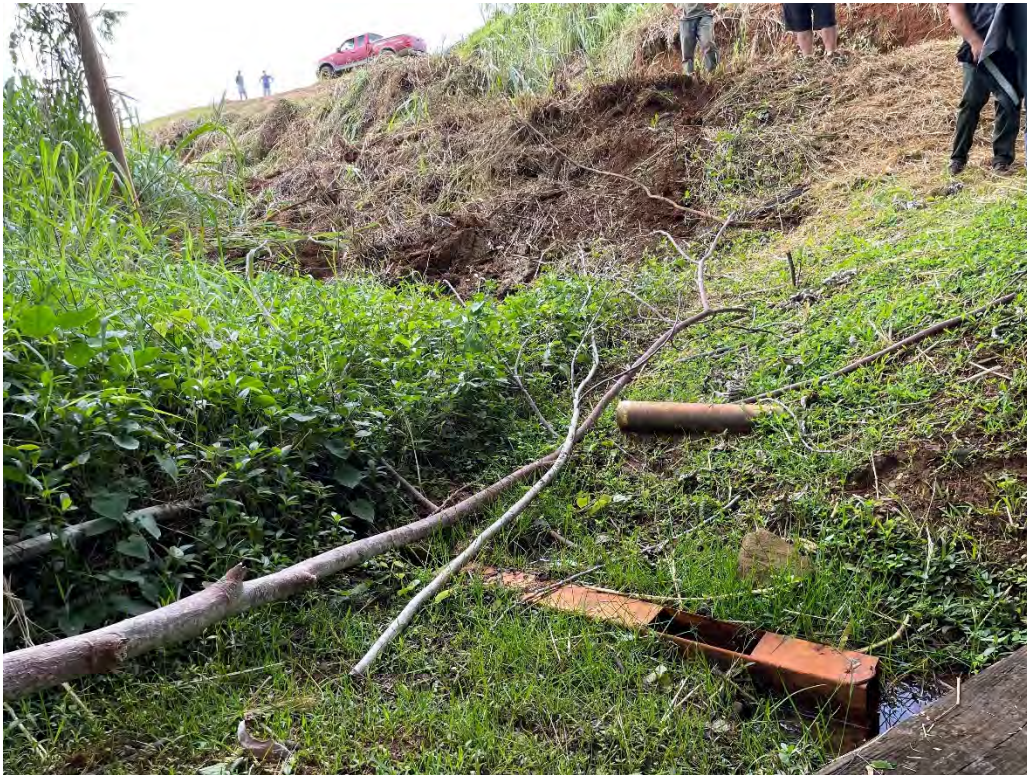
Photo B-24: Seepage Flume (S-1) at Downstream Toe of Right Embankment Segment (looking upstream and slightly right at left end of right embankment segment).

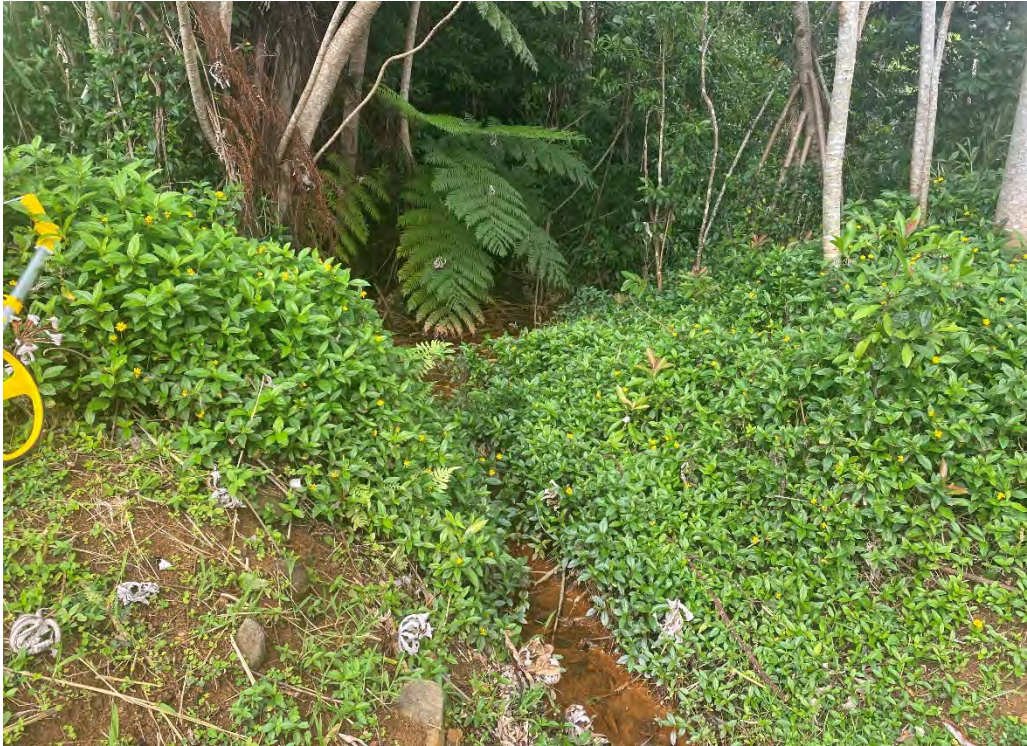
limited damage to the crest, and removal of the mid-level outlet gate structure as an emergency intervention to increase discharge capacity. The downstream toe of the right embankment has a history of seepage which continues to be monitored and has caused some erosion along the toe. There are also reports of seepage exiting above the embankment toe along the right embankment segment, particularly in areas that had slumped following the 2018 overtopping event.

Photo B-25: Area of Seepage along Downstream Toe of Right Embankment Segment
(looking downstream from Seepage Flume)

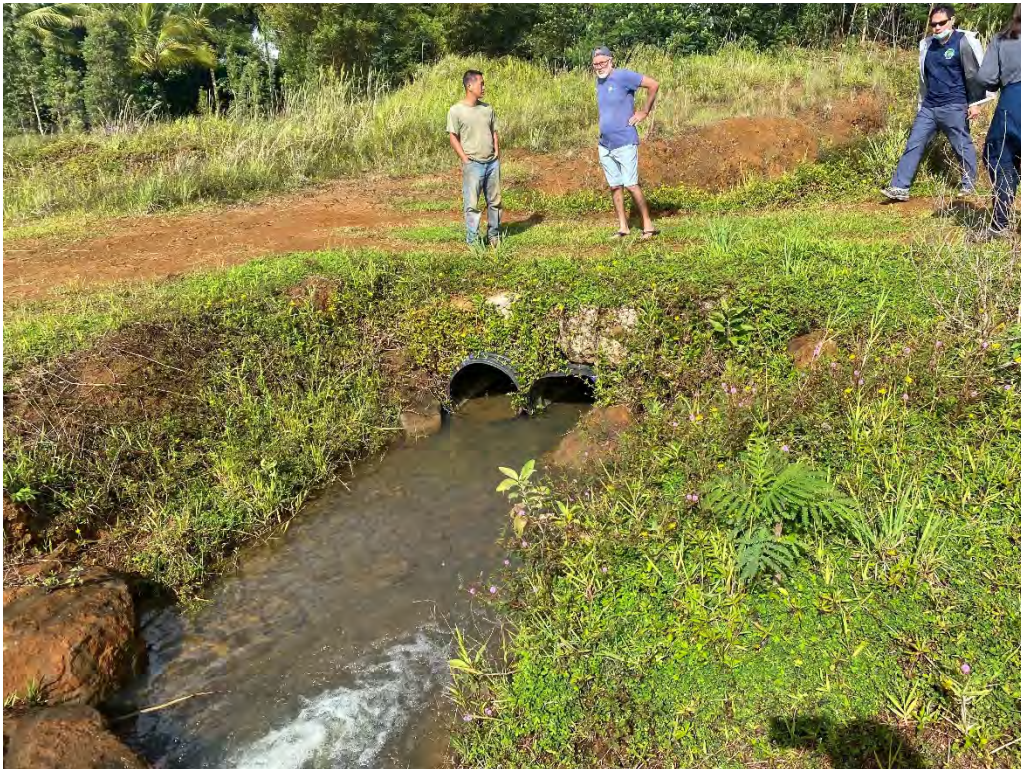
Photo B-30: Mid-level Outlet Structure (Two 24-inch Diameter HDPE Culverts)
